YAMAHA

SERVICE NEWS

TX81Z

BULLETIN NO.: E-399

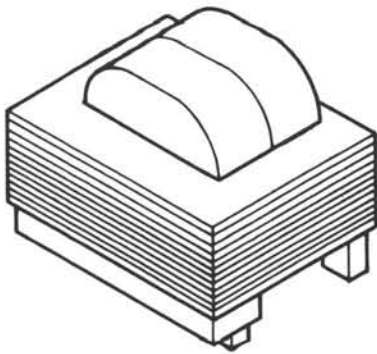
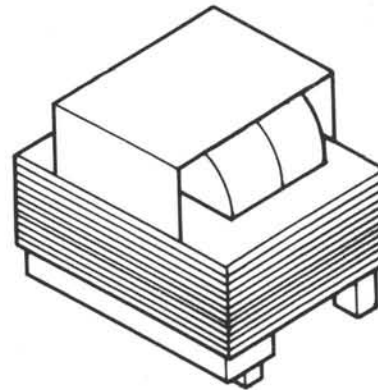
A metal cover has been added to the transformer to prevent vibration due to leak magnetic flux.

Description	Part No.	Remarks
Power Transformer	XB358002	U, C
Power Transformer	XB359002	H, D, A
