Factory Service Bulletin

SUBJECT: MEMORYMOOGS BELOW BULLETIN: 835
SPONTANEOUS POTENTIOMETER EDITING

DATE: November 22, 1983 (Supersedes earlier versions)

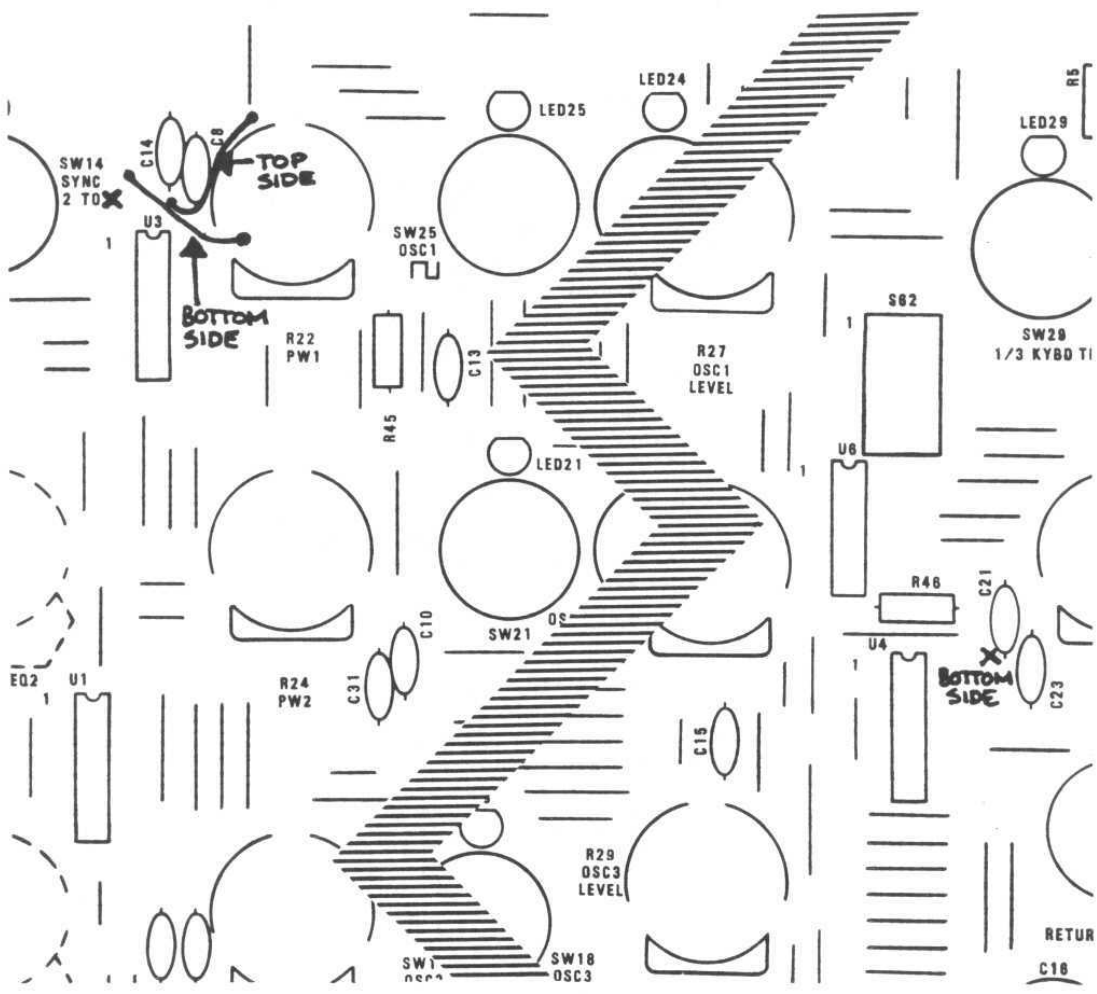
R.S.C. PRINTED CIRCUIT BOARD SCHEMATIC (BOARD NO. 6)

CAUSES: Digital to analog ground loop and no +15 volt power supply to U3 on RIGHT SIDE CONTROL board. High frequency HASH on MUX BUSS on DMUX board.

SPONTANEOUS POTENTIOMETER EDITING (BELOW S/N 2531)
Modify the RIGHT SIDE CONTROL board on the bottom side with the board mounted in place. Cut the trace between C21 and the jumper connected to U6 pin 7. Follow the diagram provided. This is necessary because the digital ground was inadvertently tied to the analog ground, resulting in a ground loop.

Also cut the trace between C14 and the jumper connected to U3 pin 8 at the "1" of the screened information "SYNC 2 TO 1". "Tack-solder" a 1.8" (46mm) insulated jumper between the ground side (mounting tab) of R22 and the C14 side of the trace cut at the "SYNC 2 TO 1" location - follow the diagram provided.

NOTE: ALL FLUX MUST BE REMOVED FROM THE BOARD BY THE JUMPER WIRE, OR THE EDITING PROBLEM WILL WORSEN FROM FLUX LEAKAGE. The solder (back) side of the board should also be checked for flux that may have "run" through the board by the top jumper and C14 and removed if present.
