Factory Service Bulletin

SUBJECT: MEMORYMOOGS BELOW S/N 2531
PITCH BEND AMOUNT MODIFICATION
PARTS TO BE PURCHASED LOCALLY

BULLETIN: 837

DATE: November 11, 1983 (Supersedes earlier versions of Bulletin 837)

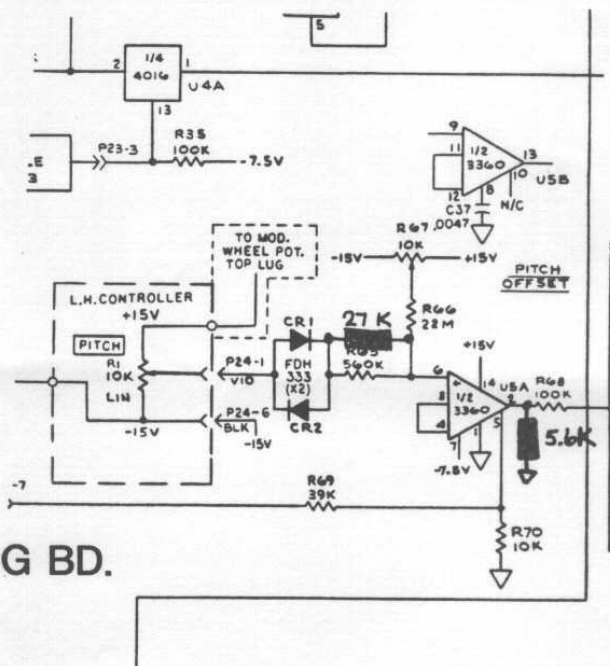
COMMON ANALOG BD.

SYMPTOMS: Tuning changes from preset to preset, caused by different programmed PITCH BEND AMOUNTS which detunes all the oscillators.

CAUSE: The PITCH BEND VCA U5A on the COMMON ANALOG BOARD develops a non-linear output offset current which varies with the control voltage on Pin 5. This modification greatly improves linearity.

- 1) Tack-solder across R65 (560K) a 27K 5% resistor, part number 852-312273-001, on the TOP (component) side of the COMMON ANALOG BOARD.
- 2) Tack-solder a 5.6K 5% resistor, part number 852-312562-001, from the front side (U9 side) of R68 (100K) to the front side of R27 (4.99K).
